CITY OF NORTHAMPTON – PUBLIC WATER SUPPLY

YEAR 1 IMPLEMENTATION OF FOREST STEWARDSHIP PLANS ON WATER SUPPLY PROPERTY

PHOTOGRAPH UPDATE – MARCH 10, 2014

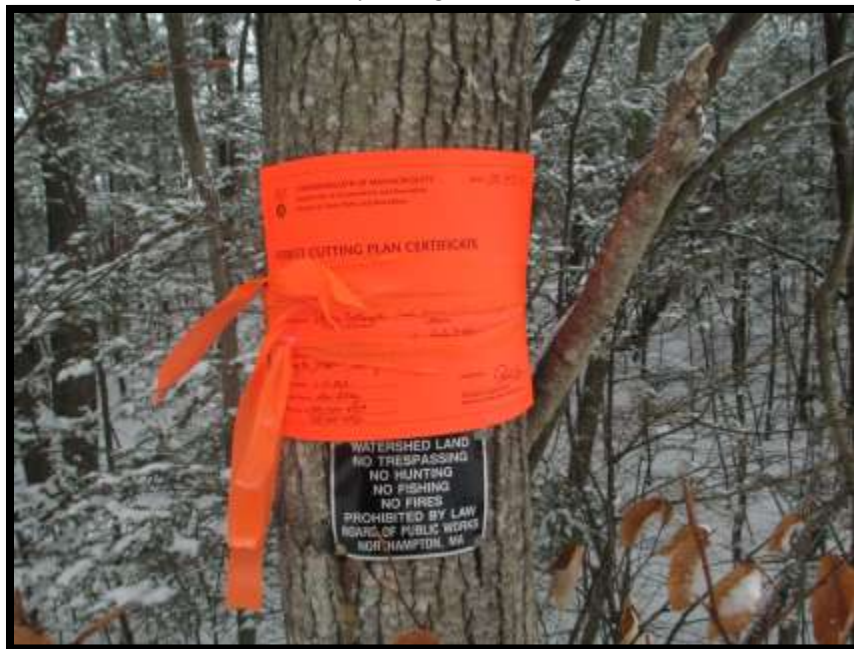
Forest Cutting Plan Certificate issued by Department of Conservation and Recreation (DCR). Most timber harvesting in Massachusetts falls under the jurisdiction of Massachusetts General Laws, Chapter 132; which requires the landowner to prepare a forest cutting plan and submit it to DCR for approval. A copy of the cutting plan is sent to the Conservation Commission within the municipality where the harvest will occur and they have an opportunity to review. If the proposed harvesting falls within a known or anticipated habitat of a rare, threatened or endangered species the plan is reviewed by the Natural Heritage and Endangered Species Program (NHESP). If all the requirements of the law are met, DCR issues the permit and the Forest Cutting Plan Certificate (orange sign) which is to be posted at the logging area.

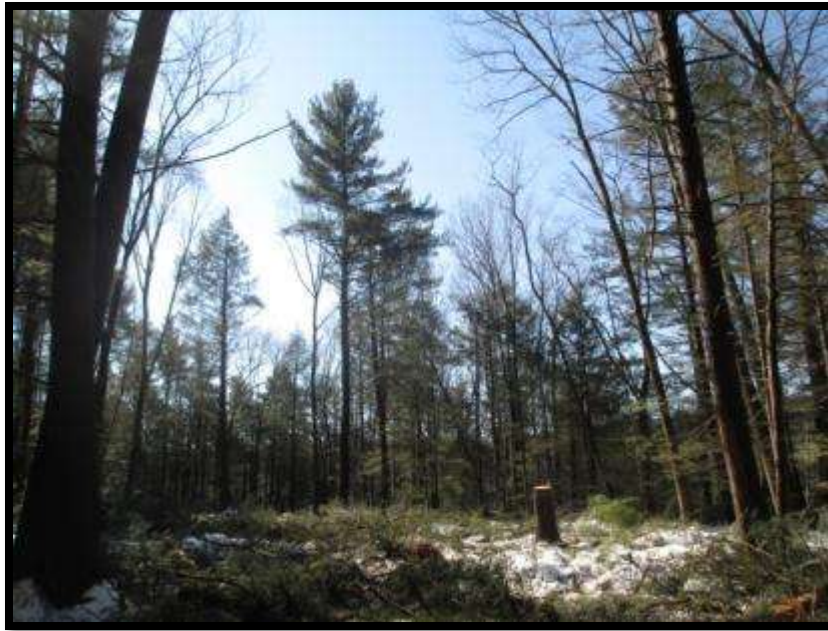
Post-harvest photograph of a small opening in the forest created by the cutting of hemlock (timber & pulp) and firewood (mostly, black birch). New trees can become established in the opening and the tall trees around the edge (white pines and oaks) will get more sunlight and their growth will improve. Many of the hemlocks that were not cut are likely to die due to the elongate hemlock scale and/or the hemlock woolly adelgid, but were left to serve as eventual snags, an important wildlife habitat for certain species and later will provide habitat on the ground. The stump and extra branches ("slash") on the ground will benefit the soil (through decomposition) and will also serve as wildlife habitat.

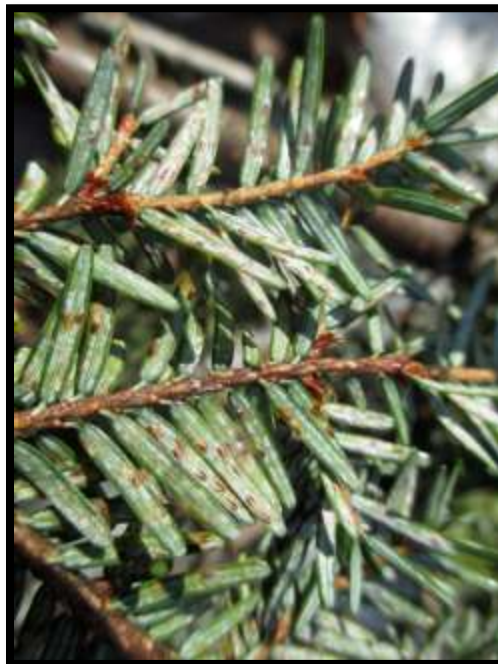
Image of the elongate hemlock scale shown on the underside of hemlock needles. Elongate hemlock scale is an introduced pest that is causing (along with the hemlock woolly adelgid, another introduced pest) a prolonged process of decline on hemlock populations in our area. Evidence of the possible presence of this scale or woolly adelgid consists of thinned crowns.

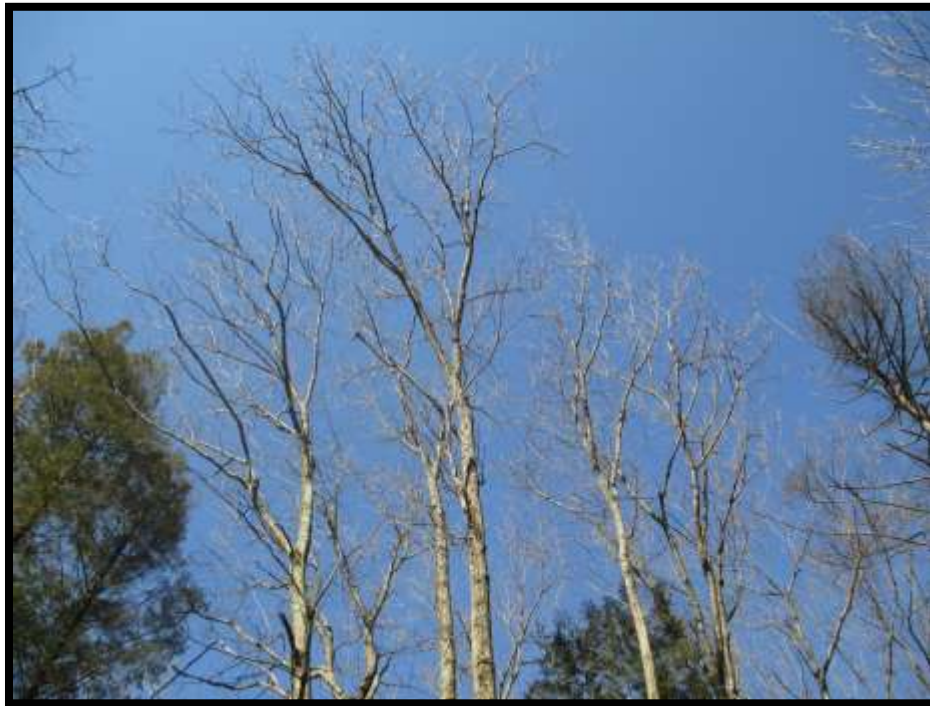
Post-harvest image of crowns of red oak trees in winter with room to grow. Dead hemlock to the right of the oaks will provide habitat for a range of species including woodpeckers, birds and other small mammals. Hemlocks in the background show the thinning effect caused by scale and wooly adelgid insects.

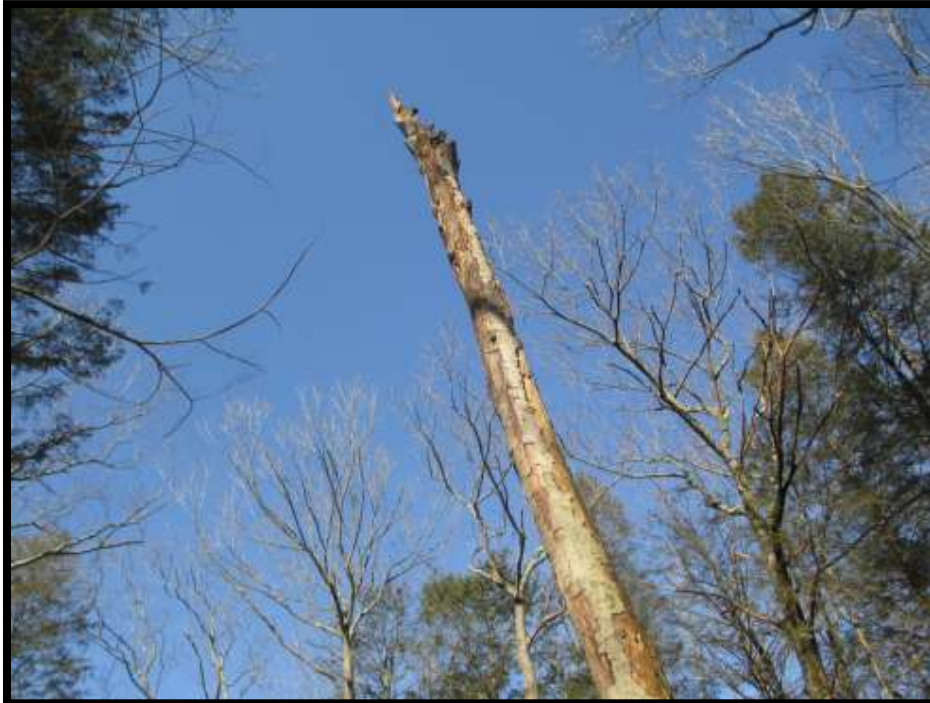
Post-harvest image of a standing dead tree, often referred to as a snag, of American beech in a small opening. The crowns of the red oak trees around the edge of the opening will benefit from increased sunlight. Note the thin crowns of the hemlocks in the background.

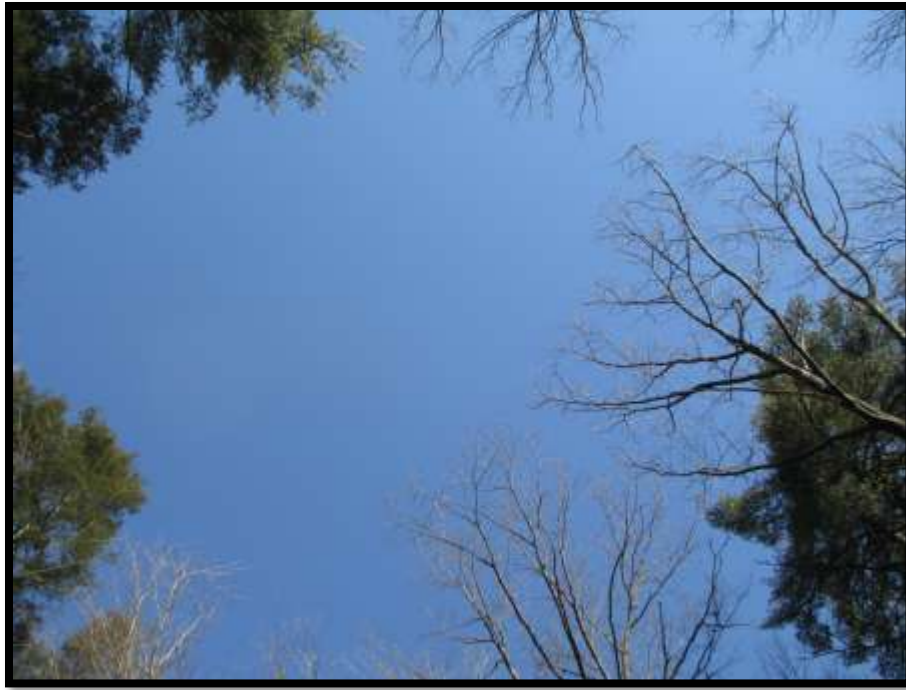
Post-harvest view of the canopy after a small opening was created. While this opening will allow for the establishment of new seedlings, the main benefit is the thinning of the area giving the tall tree crowns (red oaks and hemlocks) more room to grow. Future cuttings could enlarge openings such as this to allow better establishment of seedlings. The long term objective is to have a forest that is well stocked with native trees of all ages and sizes.

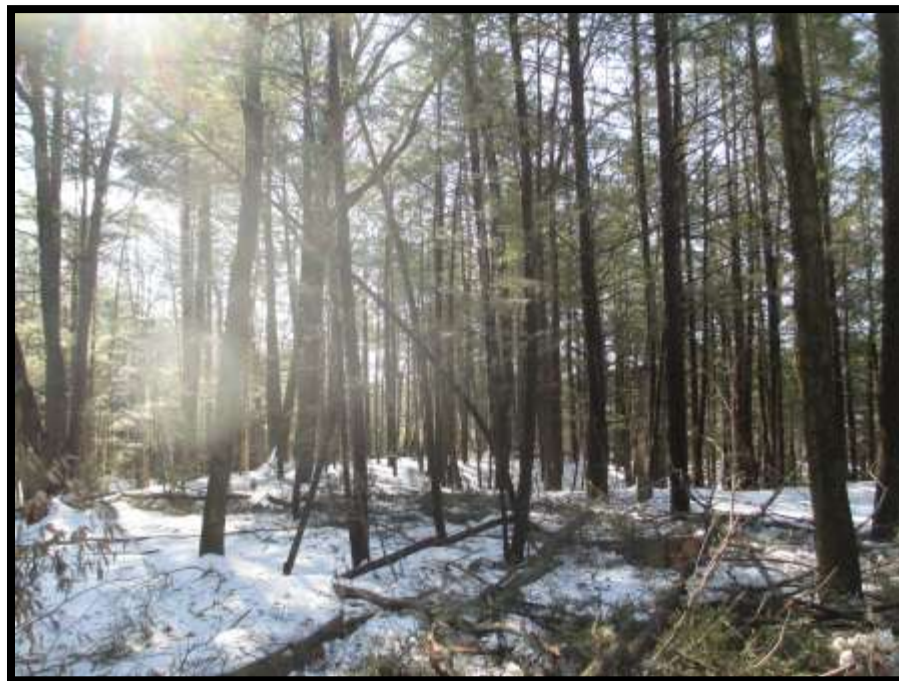
Post-harvest image of slender oaks and hemlocks in a dense grove. The thinning was designed to give more light to the tree crowns by removing competing trees. Most trees cut in this project were black birch and hemlock. Leftover branches ("slash") were left on the ground and will serve as habitat. Decomposition of this material will enrich the soil. In steep areas, slash can be used to minimize erosion and stabilize logging trails. Another way to avoid erosion is to avoid logging on steep ground. In this stand, no logging was done on any of the steep terrain.

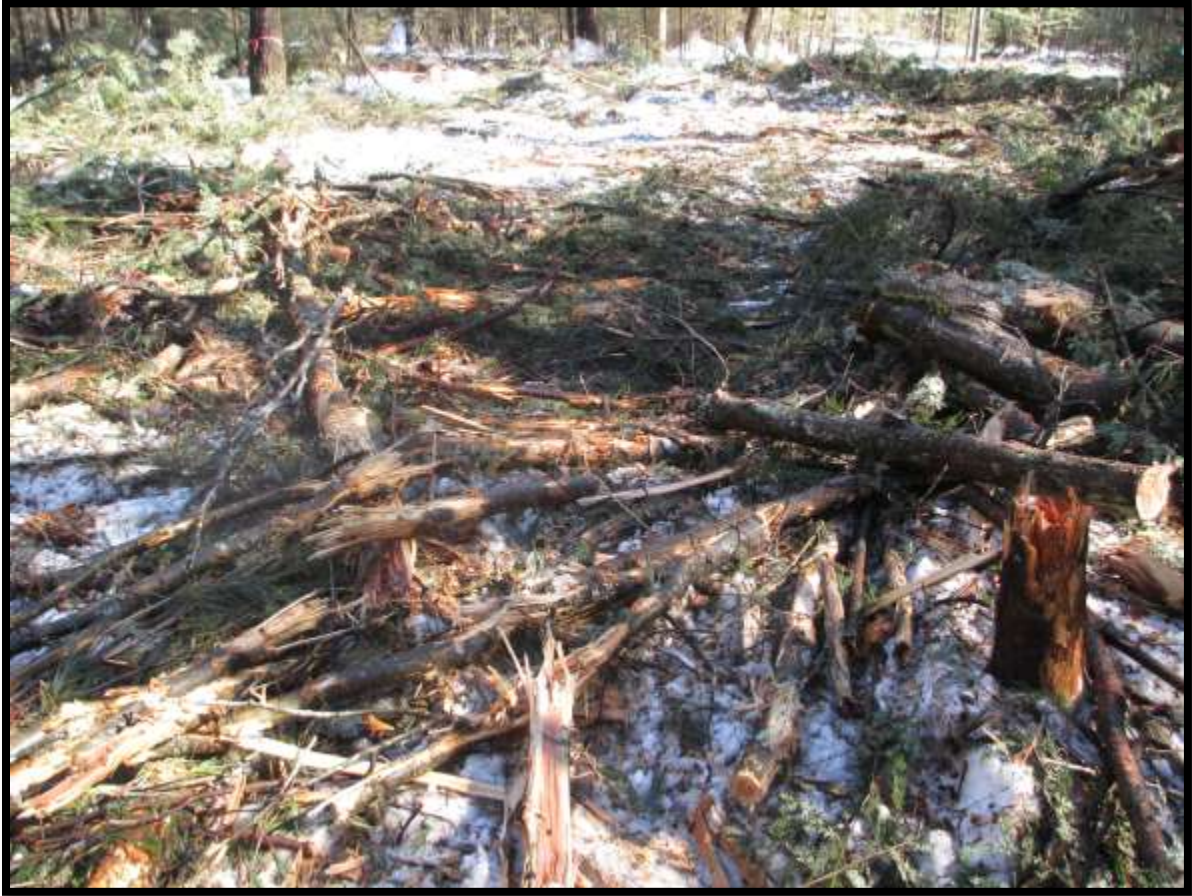
"Slash" on the ground in an opening created in 2014 harvest. The term "slash" describes the branches, tops, and other parts of trees that are left behind in a logging operation after the trunk of the tree is taken. The quantity of slash produced increases when the trees to be cut are of low commercial quality (because less of the tree is usable). With one exception (discussed below), the slash does not have any commercial value. During a harvest, the slash acts as a mat to reduce potential impacts of logging equipment on the soil. Over time, the slash will protect the soil and ultimately decompose and improve the soil by adding both organic matter and nutrients while providing important wildlife habitat. In some cases, slash can prevent erosion, though that is not a factor in this picture.

There are logging systems that will remove most of the slash. These are generally referred to as whole-tree chipping systems, and the chips are generally taken to be burned in electricity generating plants (e.g., in Westminster, MA) or in co-generation facilities, such as Cooley Dickinson Hospital. One benefit to whole-tree chipping systems is that they create a "cleaner" effect. This effect may be important if recreational use of the land is a priority, if there is a fire hazard concern, or if the land is being cleared for a different purpose (e.g. pasture or development).

In preparing this harvest out to bid, the City specifically excluded whole-tree chipping systems in the expectation that the greatest short-term and long-term benefit to the forest will come from leaving the slash.

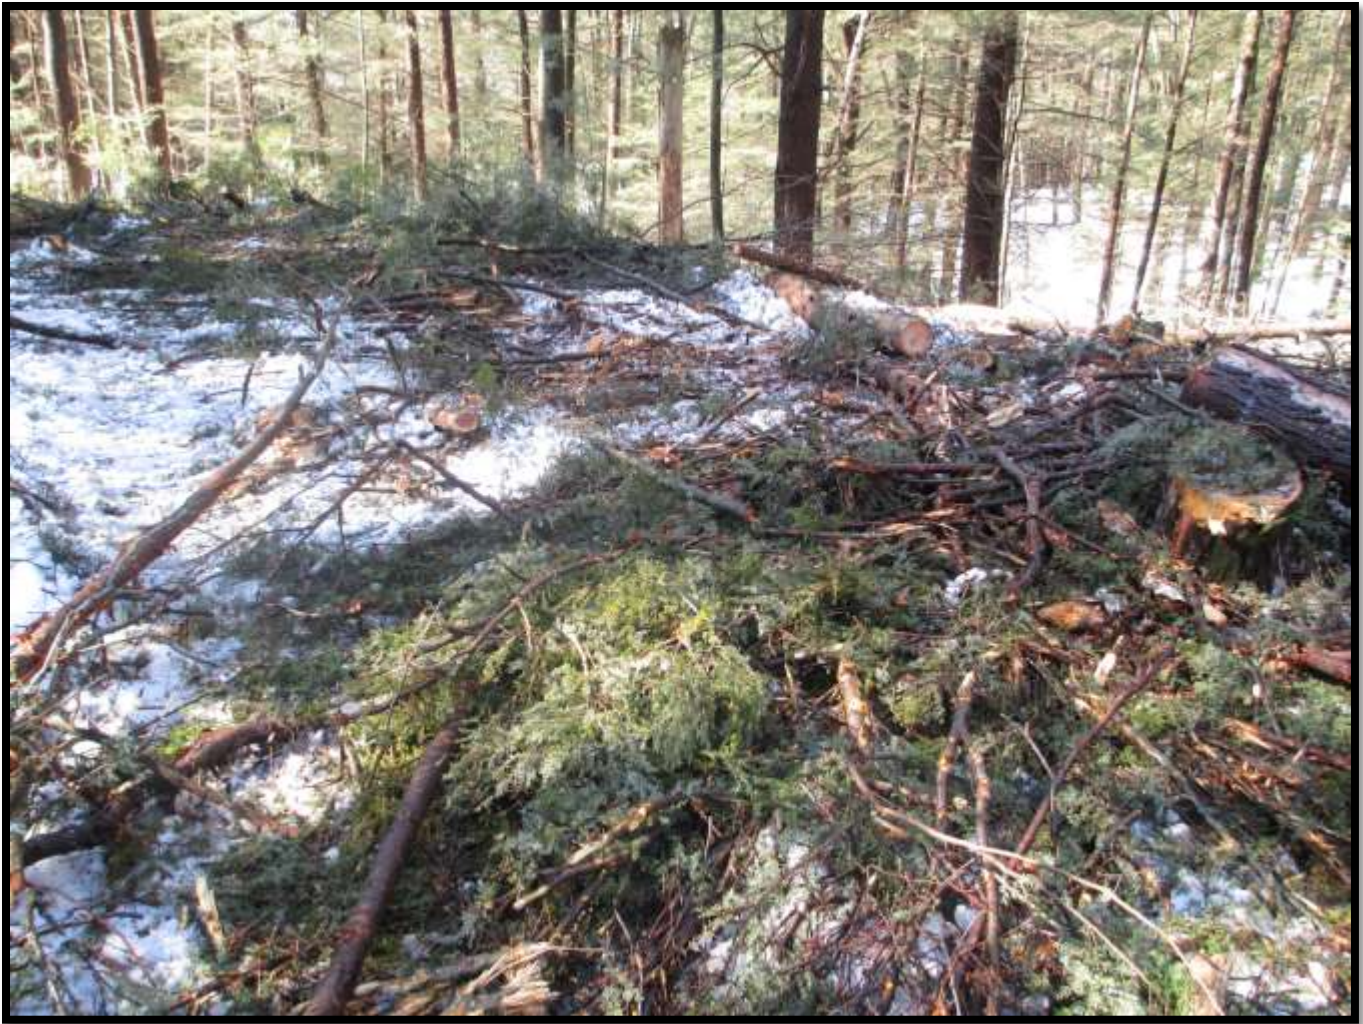
Another image of slash (hemlock and black birch) at the edge of an area where no cutting was done. Slash isn't necessarily pretty and certainly isn't fun to walk through, but in this stand, about 20 acres out of 45 acres was cut, so it is not hard to walk around the slash if necessary. The slash in this photo will decompose and will be replaced by new trees or shrubs. Massachusetts forests are very dynamic. This forest was once a farm. In order to create that farm, the original forest had to be cut down and used for timber and firewood and the rest burned. The stumps were pulled out of the ground and the land was kept in a grassy condition for decades if not 100 years or more. When the farming was done, the land was abandoned and grew naturally back into a white pine forest. When that forest was cut off for timber, it grew into the present hemlock-oak-birch mix, with smaller amounts of pine. The management undertaken here will not clear the forest but, instead, will add structural diversity, allowing new trees to grow in small pockets up to about 3/4 acre in size within a framework of surrounding, taller older trees. The intention is to have a diverse and vigorous forest. The climate, soils and tree species of Massachusetts are very well suited to this.

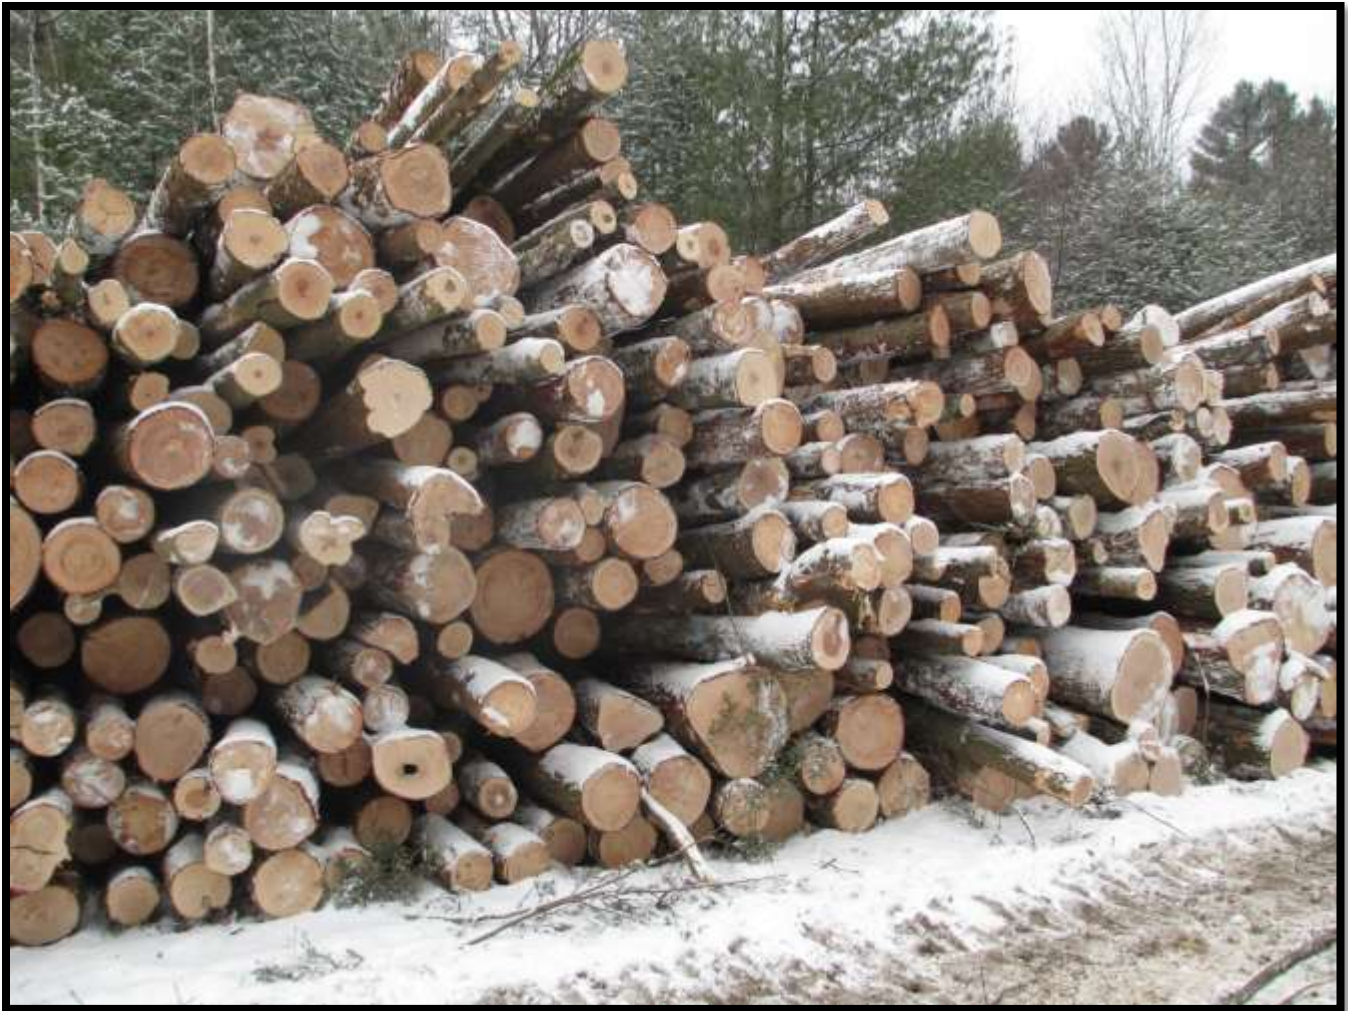
Pile of firewood from the City of Northampton water supply property. Firewood is an important local commodity and tradition in New England. If ordering a cord of seasoned, cut and split wood (say, for \$250) seems like quite an expense, it is NOT because the wood itself is so valuable. Standing firewood (trees to be cut in the forest) is usually valued at about \$10 per cord. The rest of the \$250 charge reflects the labor and equipment to do the logging, trucking, processing, storing, and delivering of the wood. Some people have full length firewood delivered to their house and save money by cutting, splitting and seasoning it themselves.

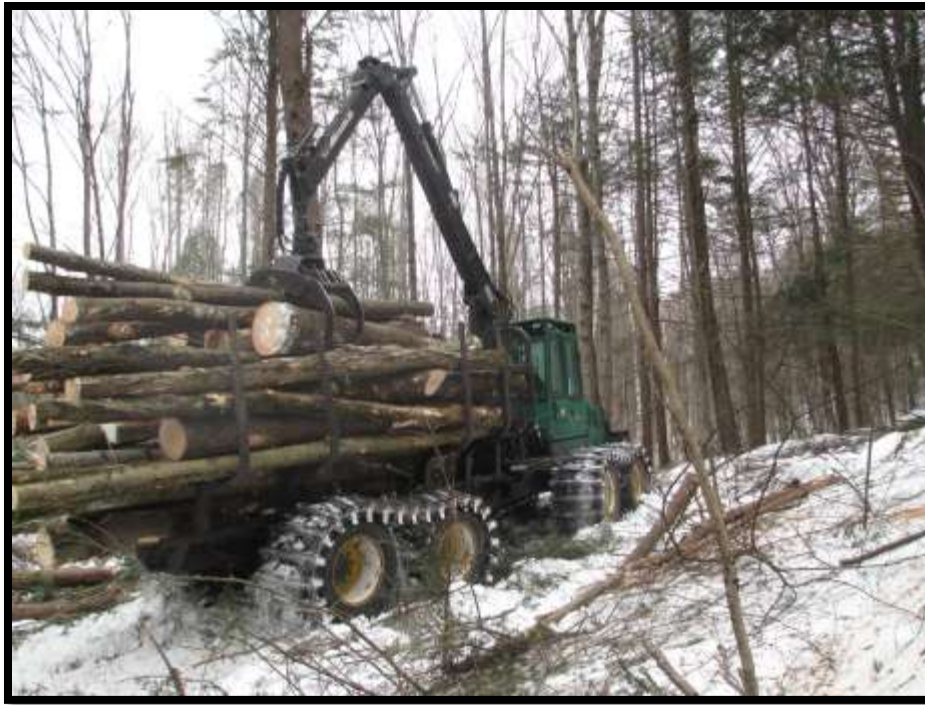
Forwarder loaded with firewood and pine logs driving through snow. The forwarder is an 8-wheel machine with 4 pairs of wheels enclosed in tracks. The logs are self-loaded into the bunk by the loading arm. The bunk of the forwarder can also be used to carry smaller branches and "slash" to lay down in wet or low spots in the logging trails, and the loader arm can be used to set these materials in place.

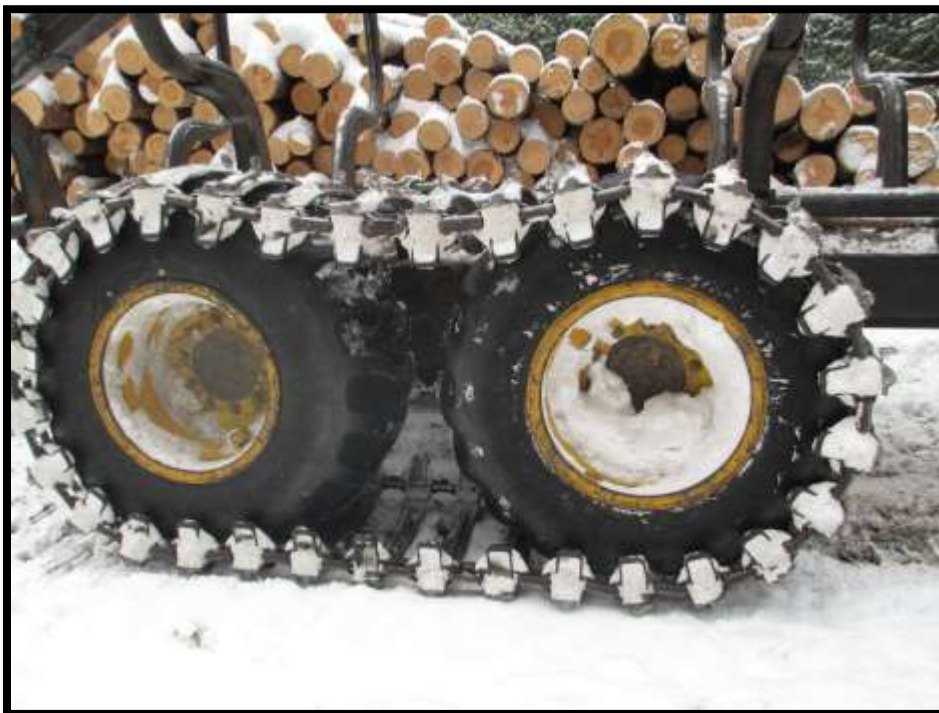
Set of two rubber tires on a forwarder enclosed in a metal track. The forwarder is used to carry logs out of the forest. The logs are carried in a metal bunk. The track on the rubber tires helps spread the weight of the machine and improve traction and also helps protect the tires from slash, stumps, rocks, etc. Behind the empty bunk: a pile of log-length firewood.

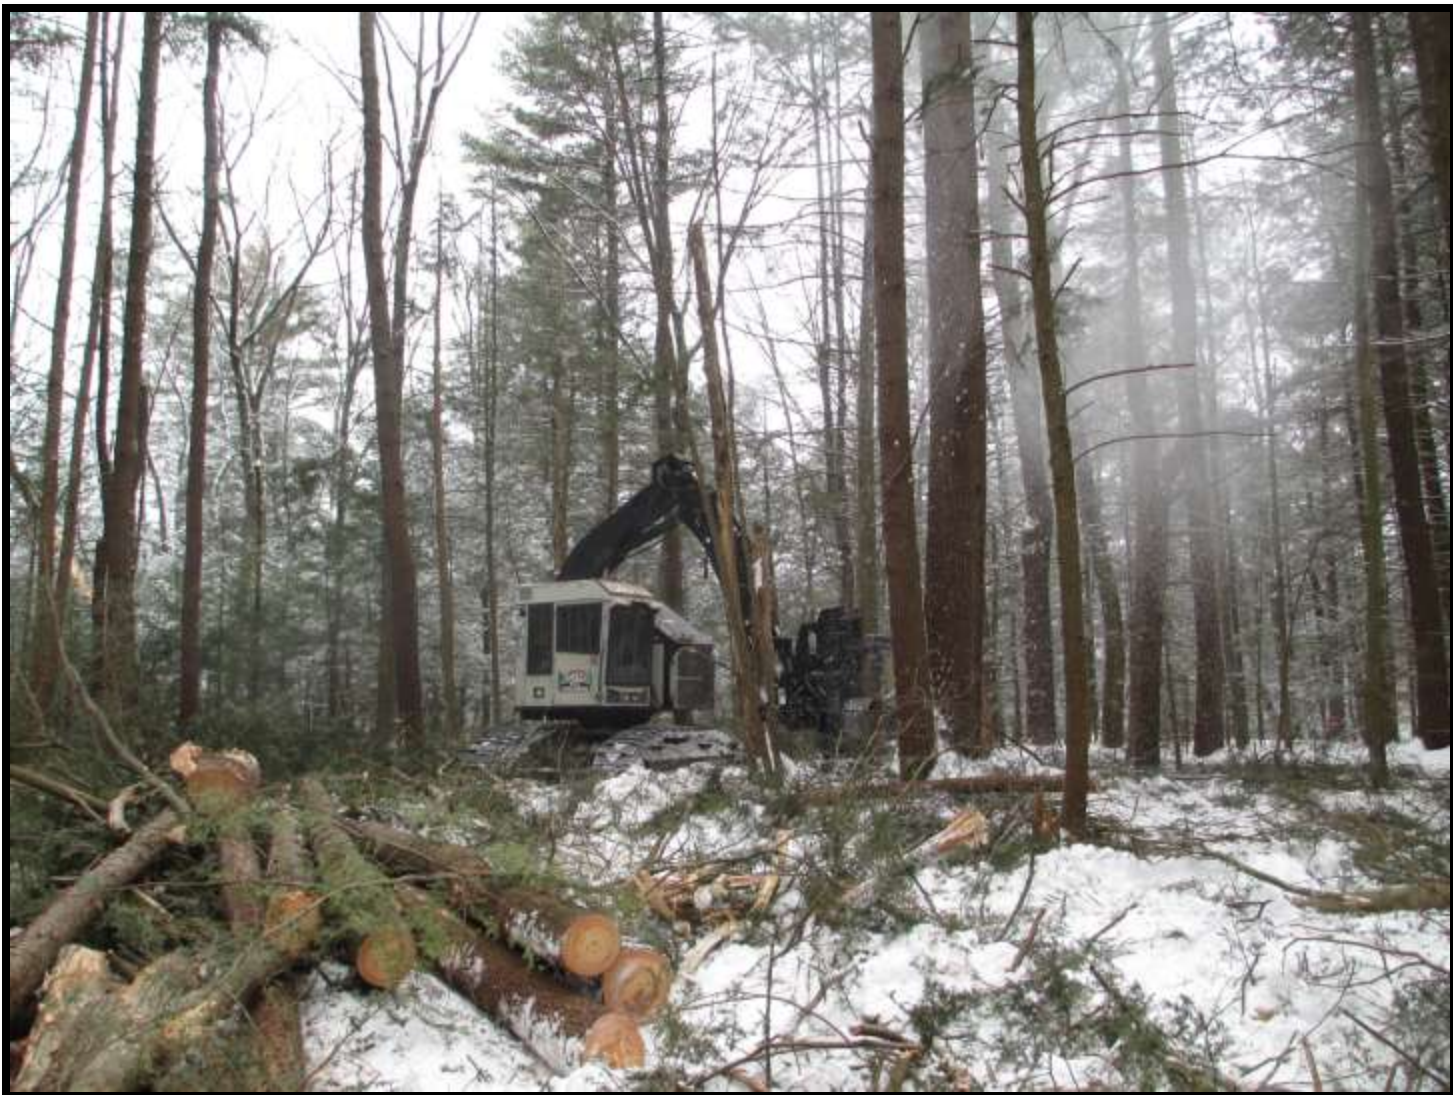
This tracked timber harvester/processor is being used to fell most of the trees for the 2014 harvesting work. The felling head at the end of the arm contains a chainsaw that cuts the tree, which is then pulled through the head and to be delimbed and cut into logs of various lengths. This type of machine is helpful when there are a large number of small- or medium-sized trees to be cut with little value. The logs (firewood, pulp and/or timber) are left in small piles that can be picked up by the forwarder. The larger trees are still cut by a logger standing on the ground with a conventional chainsaw.

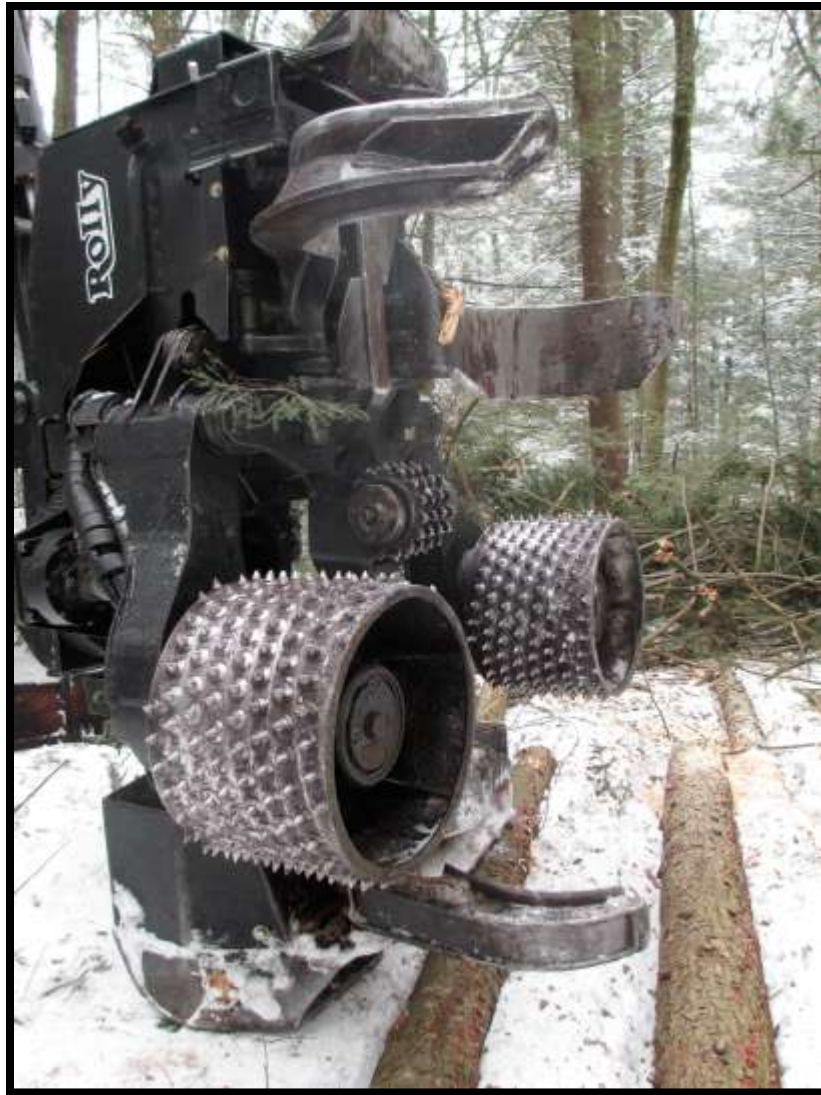
Close-up view of the felling head of the timber harvester/processor. The chainsaw bar is not visible. The large fingers grab the tree and can quickly lift the tree off the ground once it is cut; efficiently and safely. The spiked metal rollers rotate to push the log through the grip of the fingers, peeling off branches (see pile in background of picture). Without mechanized harvesting equipment, it would be difficult if not impossible for loggers to make a living cutting the large number of small- to medium-sized, low-quality trees that need to be cut in order to create the desirable forest conditions defined in the Forest Stewardship Plan for the City's watershed forest. The ability to work quickly has the added advantage of being able to capitalize on good logging conditions (i.e. frozen ground conditions) such as we have had in the winter of 2014.

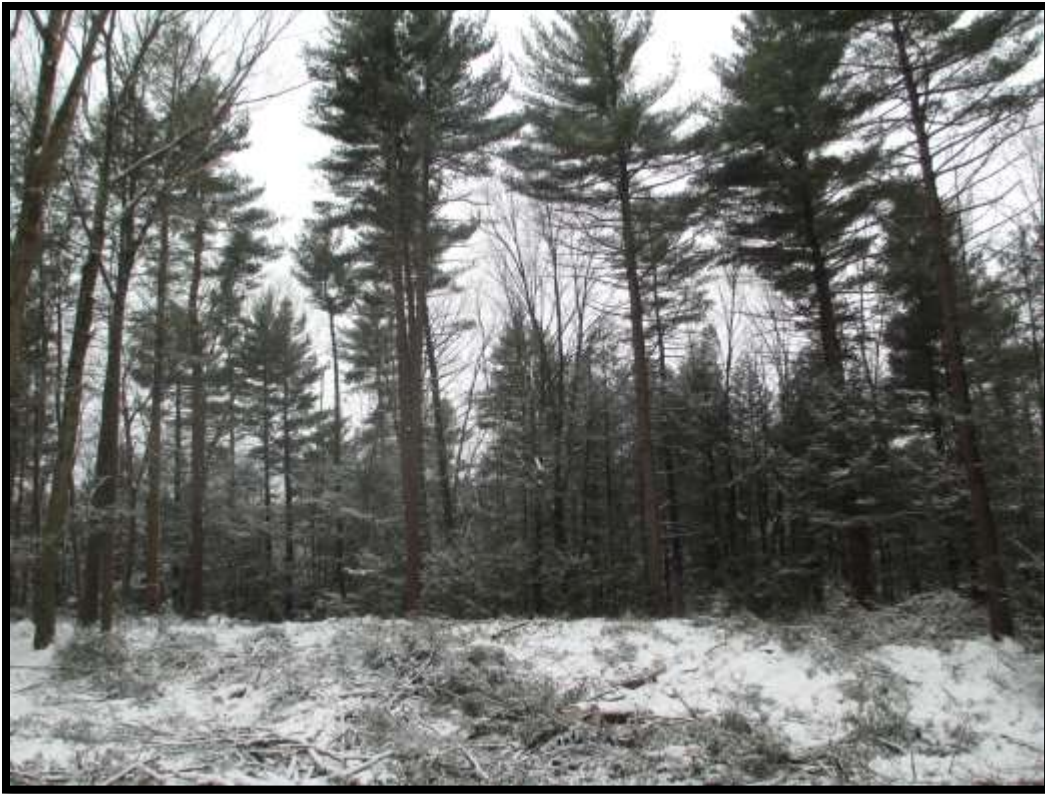
Group of tall white pines free to grow after thinning. A small opening is in the foreground.

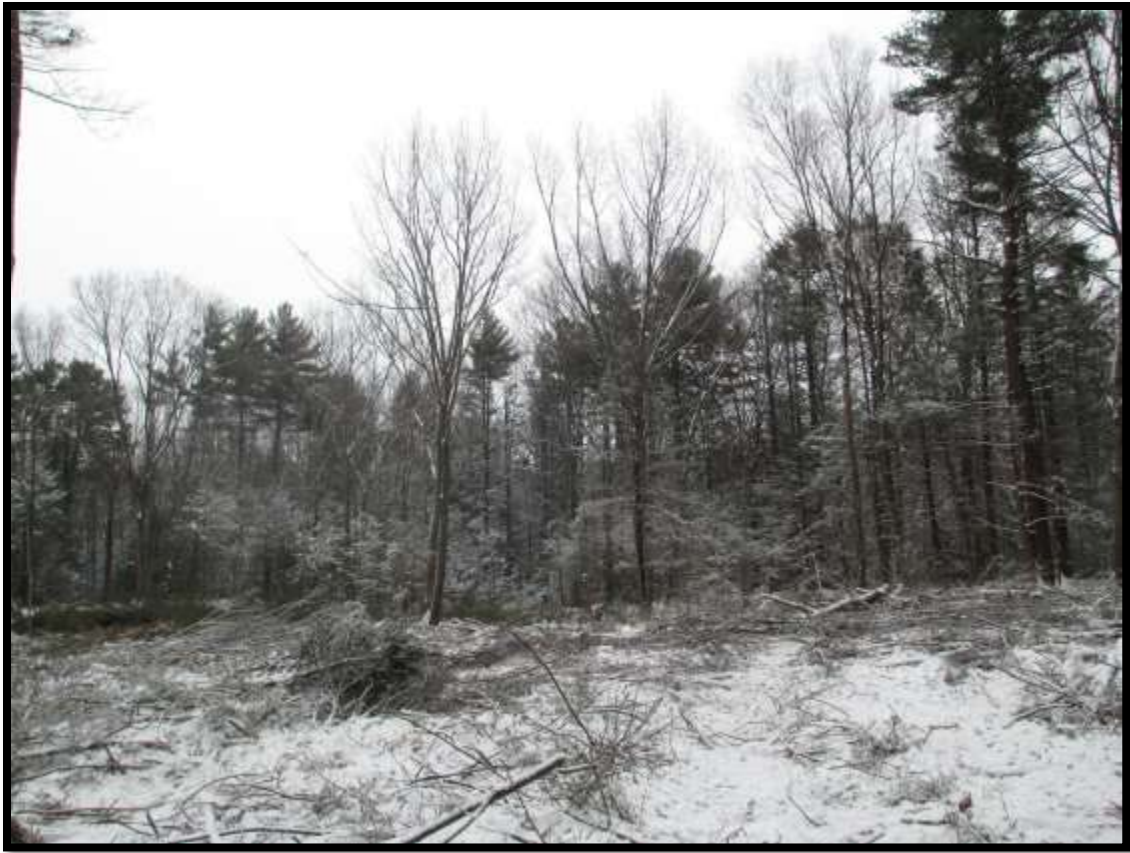
An image of one of the larger openings created during the 2014 harvest. This opening is about 3/4 acre and will fill in naturally overtime with a diversity of vegetation, including blackberries and goldenrods, as well as young trees, possibly including black cherry and/or pin cherry. The vegetation and the slash will attract a variety of insects, including pollinators, which will in turn attract a variety of birds and small mammals. Most openings are about 1/3 acre or less, such that if a tree falls into the opening, its top might reach the middle of the opening or fall all the way across the opening. Trees that become established in these smaller openings will generally require additional cutting around the edge of the opening in the future if they are to be free to grow, especially oaks or black cherries. Black birch, on the other hand, is somewhat exceptional in its ability to grow up through what is known as "tall shade".

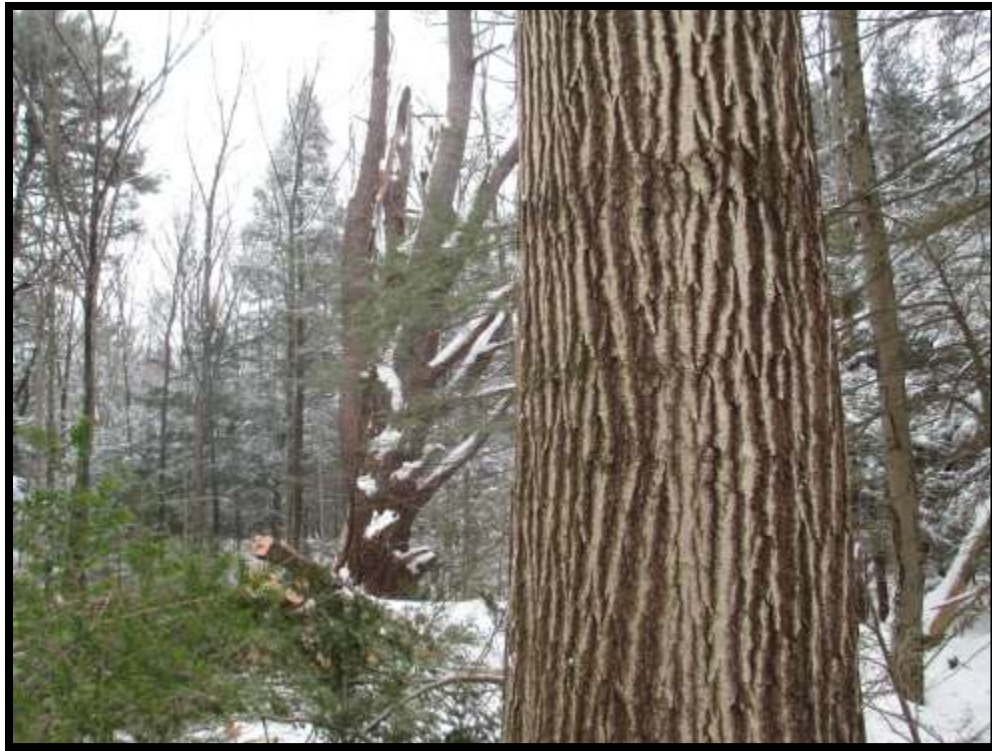
Image of a large red oak on the edge of a new opening. Note the rough white pine tree in the background, which was retained for its structural habitat value. The large crown of this oak will benefit from the increased sunlight and will produce more acorns, adding to the habitat draw of the nearby opening and hopefully (with the help of blue jays) seeding in some new oaks.

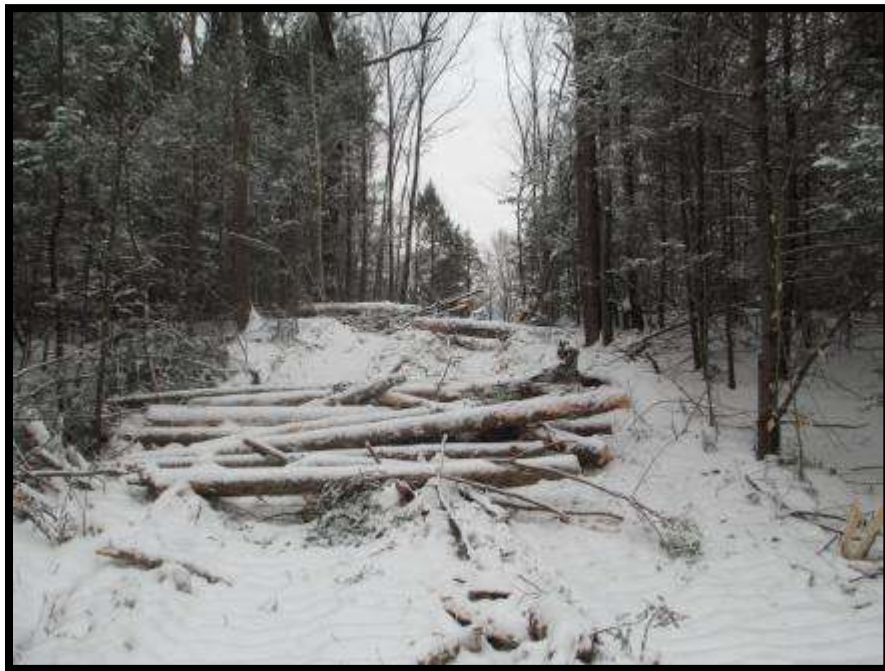
Image of a blockade of logging road using un-merchantable logs. Unfortunately, logging access into the forest usually needs to be blocked off to prevent illegal dumping, driving of vehicles, and other unwanted uses. For permanent roads at the City of Northampton watershed, gates are used. For infrequently used logging trails, using these local, handy and biodegradable barriers makes the most sense.

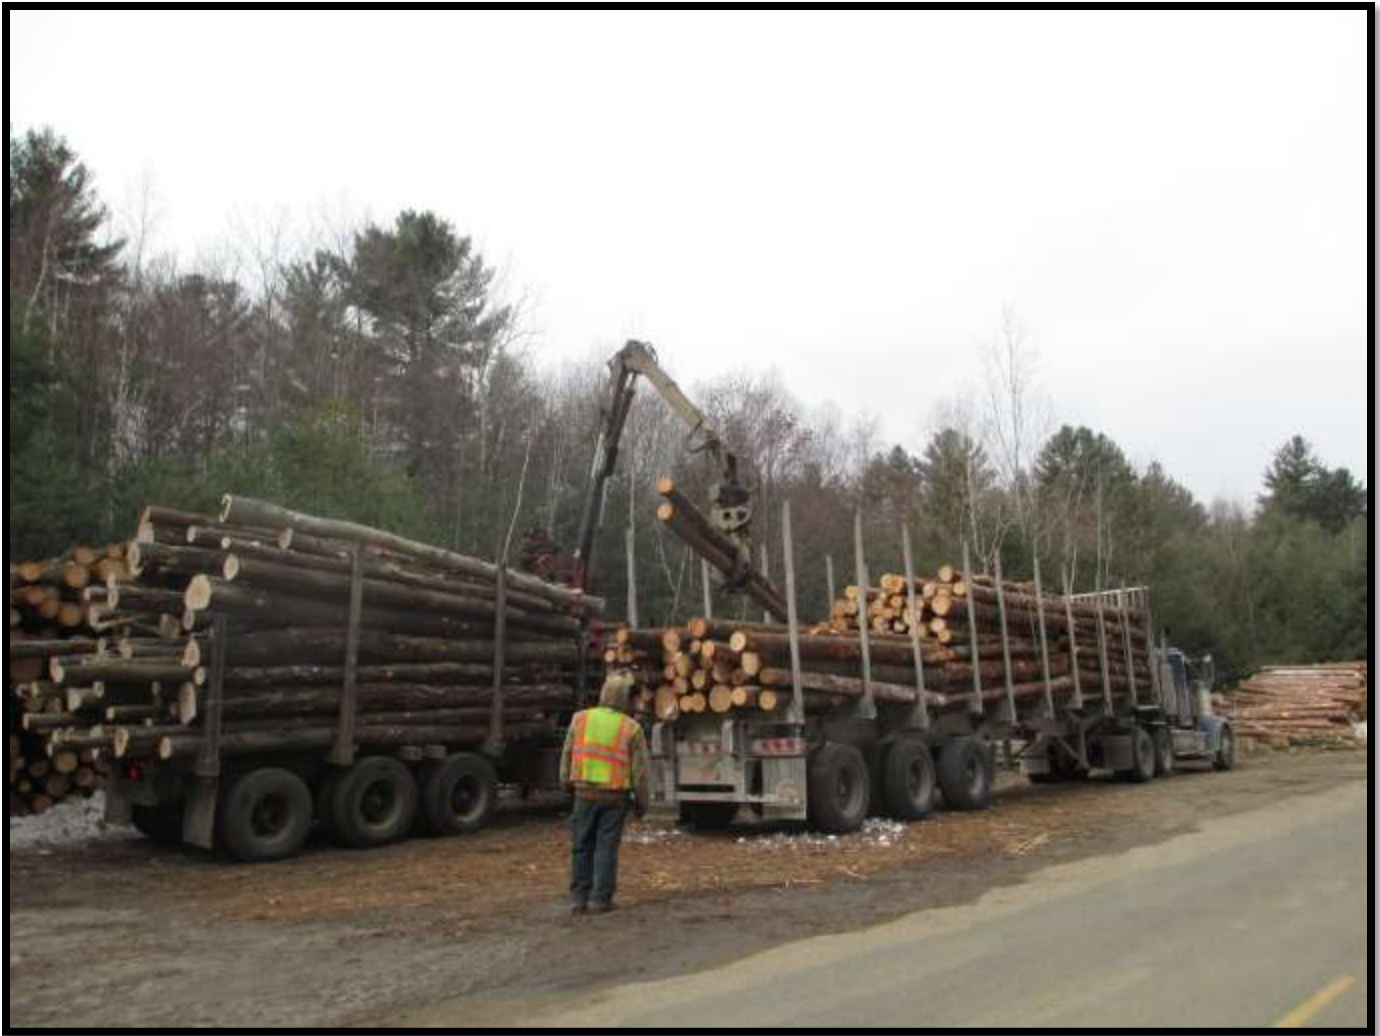
Two log trucks on the log landing. The "landing" is the area where the logs are brought out of the woods, sorted and stacked, and then loaded onto trucks. The town road is in the foreground. Often, the landing is the only part of a logging operation that people see. The truck in the back has a full load of firewood (ca. 8 cords of mostly black birch) and is loading hemlock pulp onto the flatbed truck in front. The firewood is being brought to Whately for processing and local resale. The hemlock pulp is being brought to Huntington and then re-shipped to a paper mill in New York. The log pile at the far end of the landing is red pine. The red pine logs are being brought to sawmill in Williamsburg, unless they are too small, in which case they are being sent to a sawmill in Quebec. The hardwood logs are going to a sawmill in Southern Vermont. The hemlock and white pine logs are going to the same sawmill in Williamsburg as the red pine. The slash (branches and other unusable parts of the tree) are being left in the woods to provide a range of benefits, although the slash could have been chipped and taken to a chip burning plant such as the cogeneration plant at Cooley Dickinson Hospital or the electricity plant in Westminster.

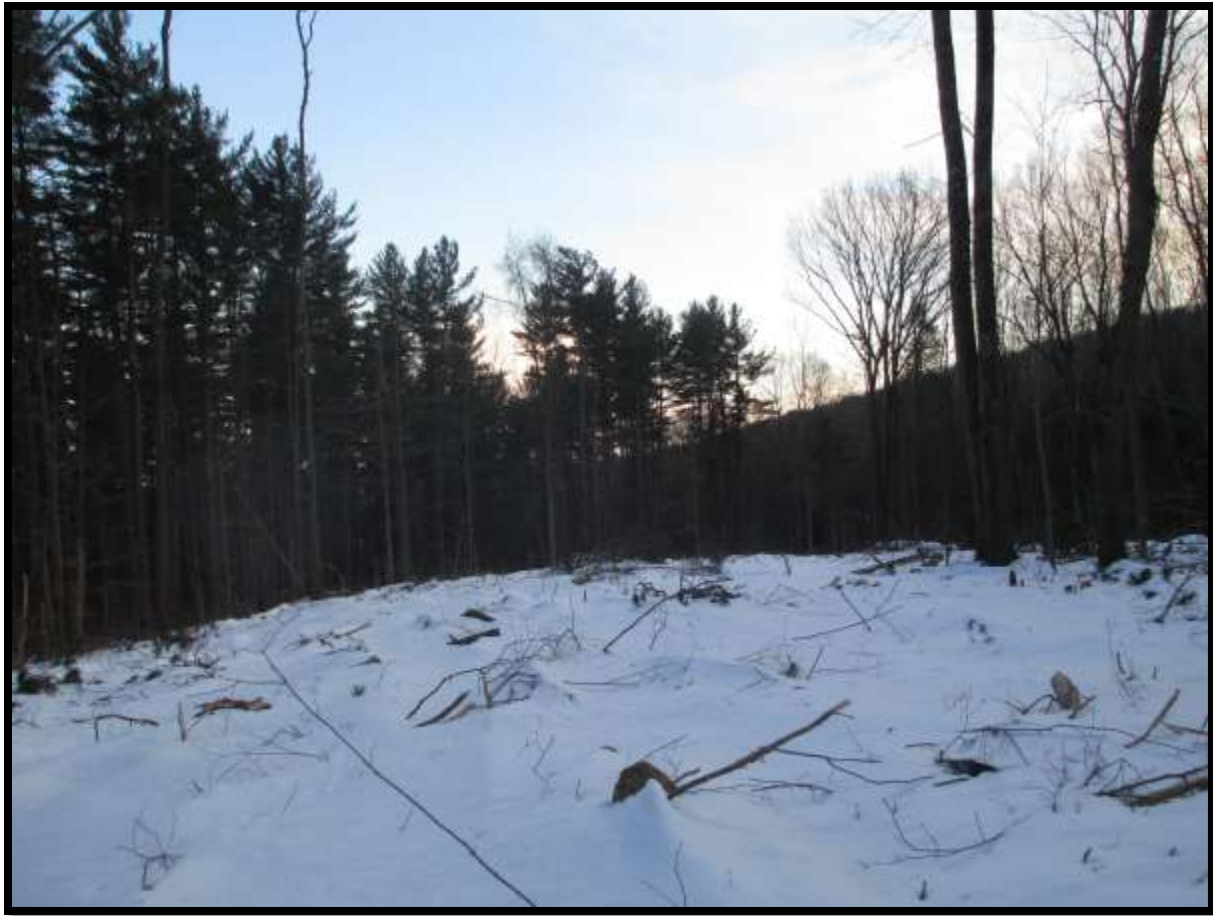
Opening of about 1/2 acre in size that was made by cutting a small plantation of red pines. Red pines were planted in various locations on the watershed about 80 years ago on old pasture land and have reached a point of stagnation in their growth due to a number of pests. Even red pines that have been thinned do not show an improvement in vigor. The small opening is bounded by a tall white pine stand to the east and a number of maturing red oaks to the west and north. With a black cherry seed source nearby, and with the ability of black cherry seeds to remain viable in the soil for many years, it will be interesting to see if black cherry trees grow in this new opening. If they do, we will keep our fingers crossed that the abundant local moose do not come through and bite off the tops.

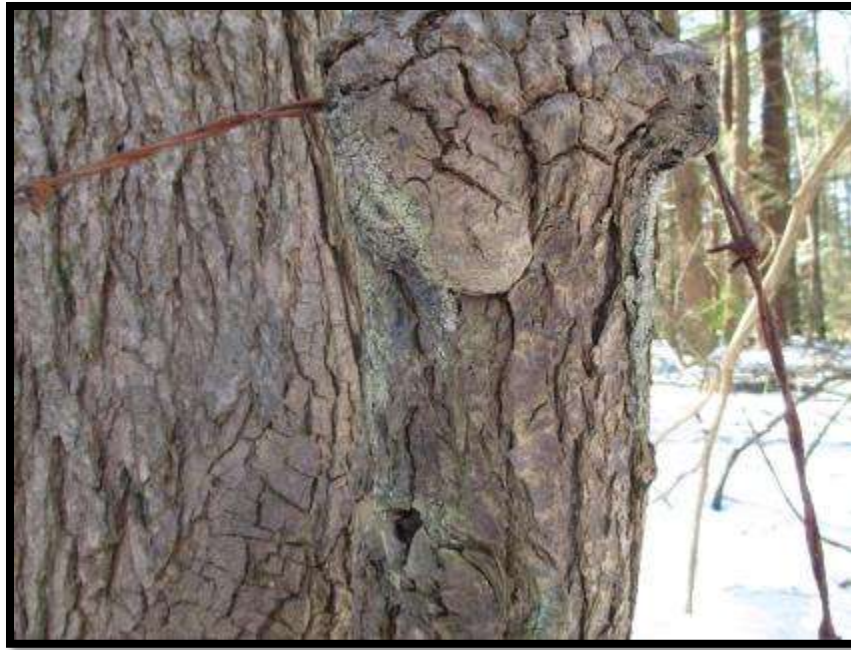
Image of barbed wire grown into an old hemlock tree in a fence row within the logging area. Like most of our present-day forests, this stand was also part of a 19th century farm that grew back into white pine after the farming came to an end. When the white pine was cut (usually clear cut), the land grew back into a mix mainly of hemlock, oaks and birches. The trees in the fence row pre-date the surrounding forest.

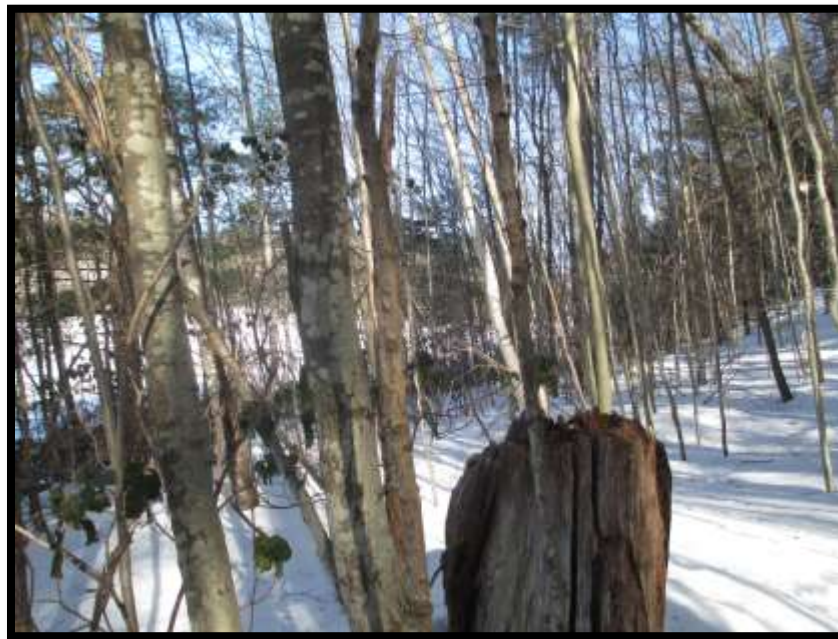
Stump (of oak) surrounded by young trees (oaks in the foreground). The stump probably dates back to the construction of the reservoir. Because of the steep slope down to this area, it was not included in the winter 2014 logging. The Forest Stewardship Plan evaluated each stand for its suitability to logging. Areas that were steep, wet, or very remote, or that were overrun with wild grapes or non-native invasive plants such as oriental bittersweet, were excluded from logging. The reservoir is in the background.

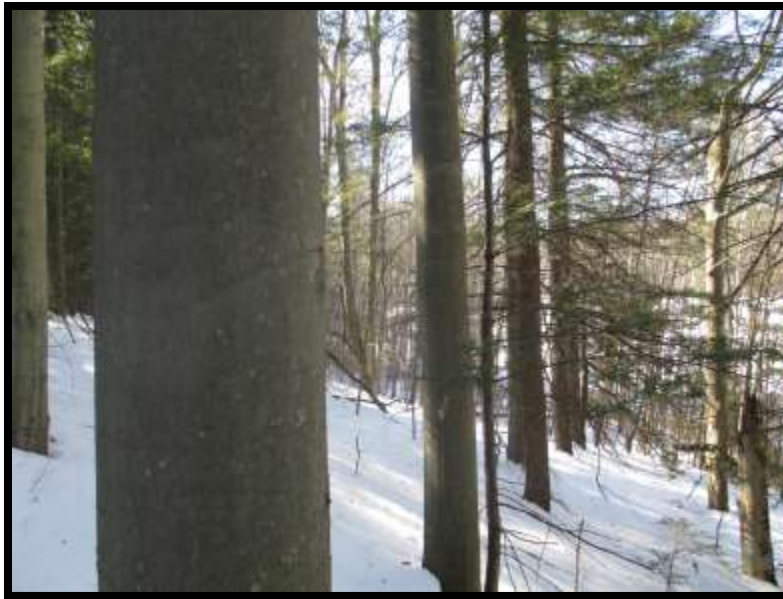
A beautiful beech tree (American beech) in one of the no-cut areas. This tree is unusual in that it (and a few of its neighbors) are not infected with the beech bark disease complex that has disfigured (with bark cankers) most of the beech in the Northeast, often causing an early death. Some beech (like these) appear to have a genetic resistance to beech bark disease complex. The beech nut is an important source of nutrition for black bears, which will climb trees to get them.
